# Regional Park.....

## Master/Concept Plan

# Appendix F

## Drainage Analysis

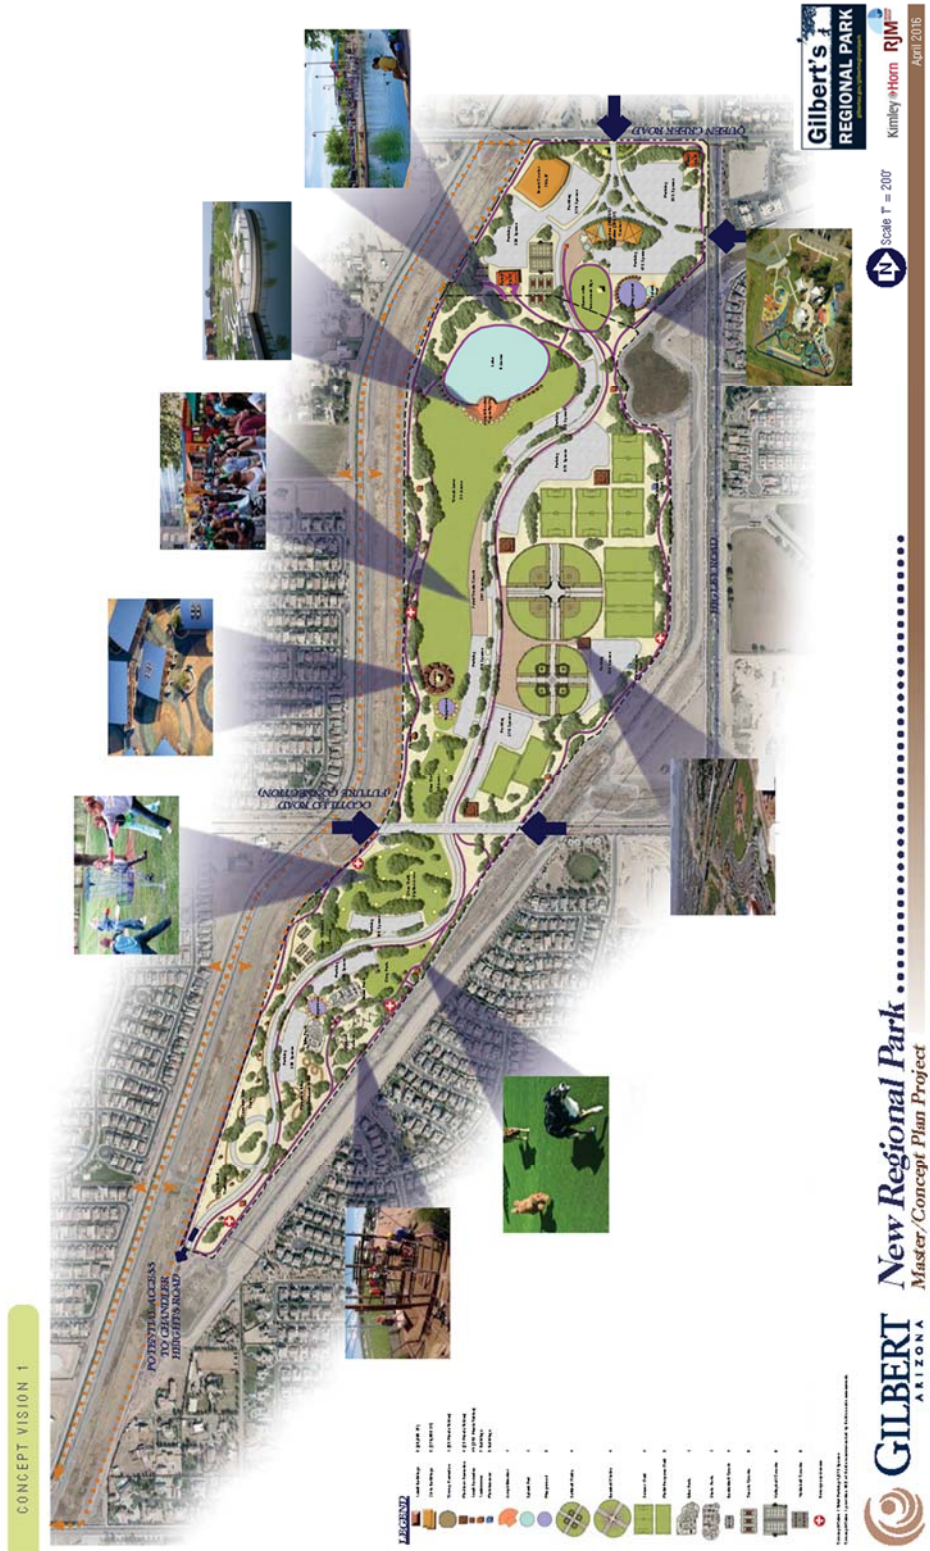
Figure 4. Opportunities & Constraints Map

Major streets adjacent to the development include Higley Road, Queen Creek Road, Greenfield Road and Chandler Heights Road. The recommended vision concept plan is illustrated in **Figure 3**. The site opportunities and constraints map can be found in **Figure 4**.

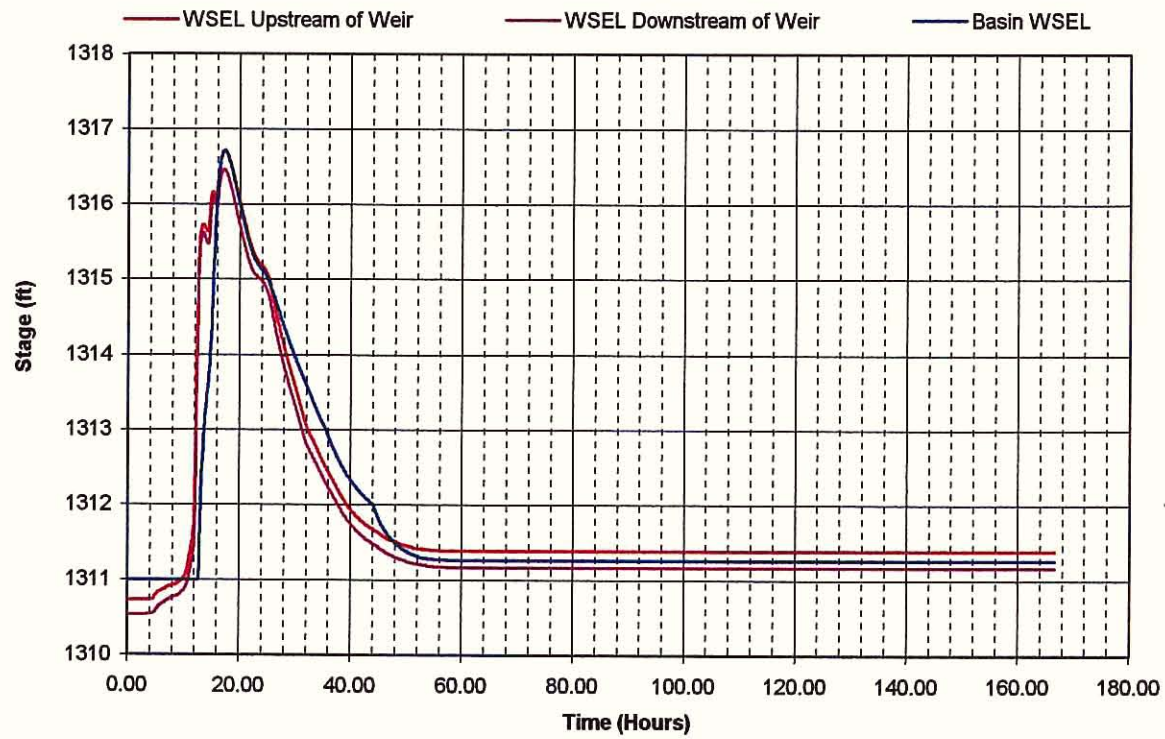
**Figure 5.2.4.2 - Flow Hydrographs at the EMF/Rittenhouse Basin Weir and Flap Gate Outlet**

Figure 5.2.4.2 shows the impact of the operation of the basin and lateral weir/flap gate outlet on flow in the EMF channel.

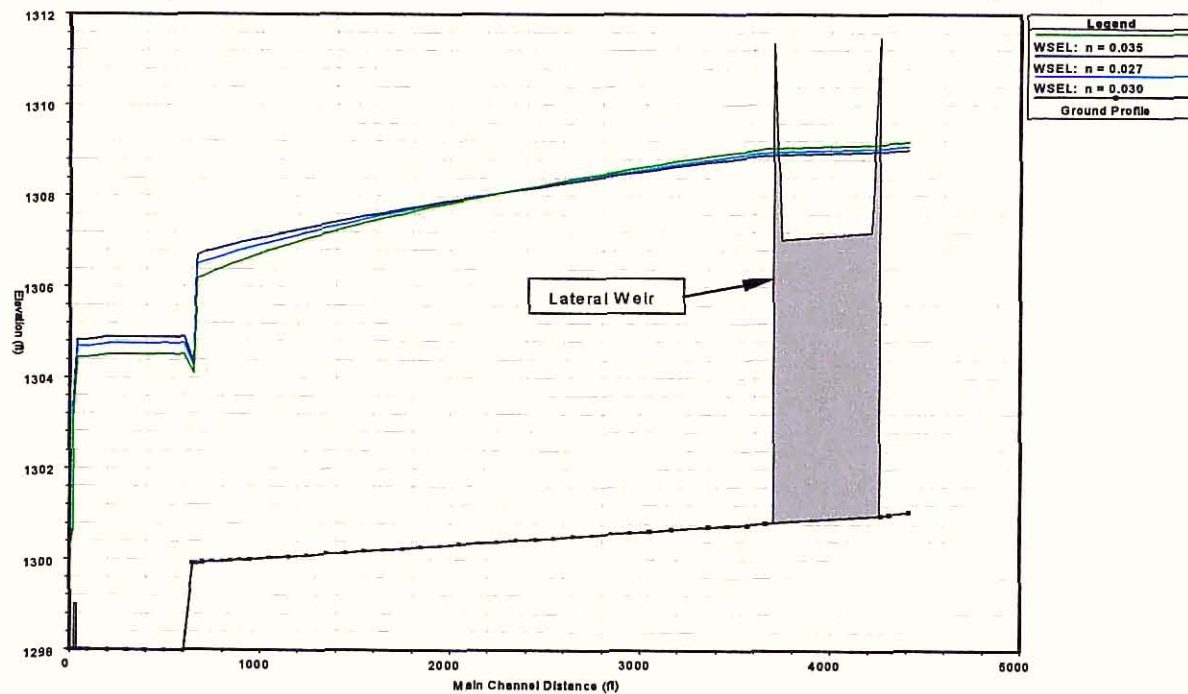
**Figure 5.3.2.1: Queen Creek Channel 'n' Value Sensitivity Analysis**

Figure 5.3.2.1 shows the impact 'n' values of 0.027, 0.030, and 0.035 have on the water surface elevation in the Queen Creek channel. At the critical location of the lateral weir, the increase in 'n' value from 0.027 to 0.035 increases the water surface profile by approximately 0.1 feet. The increase in water surface elevation increases the amount of flow over the lateral weir 100-200 cfs (Figure 5.3.2.2). This increases the maximum stage in the detention basin by 0.5 to 1.0 feet and the amount of detention storage by 100 to 270 acre-ft. Channel velocities in Queen Creek decrease by 0.5 fps or less.

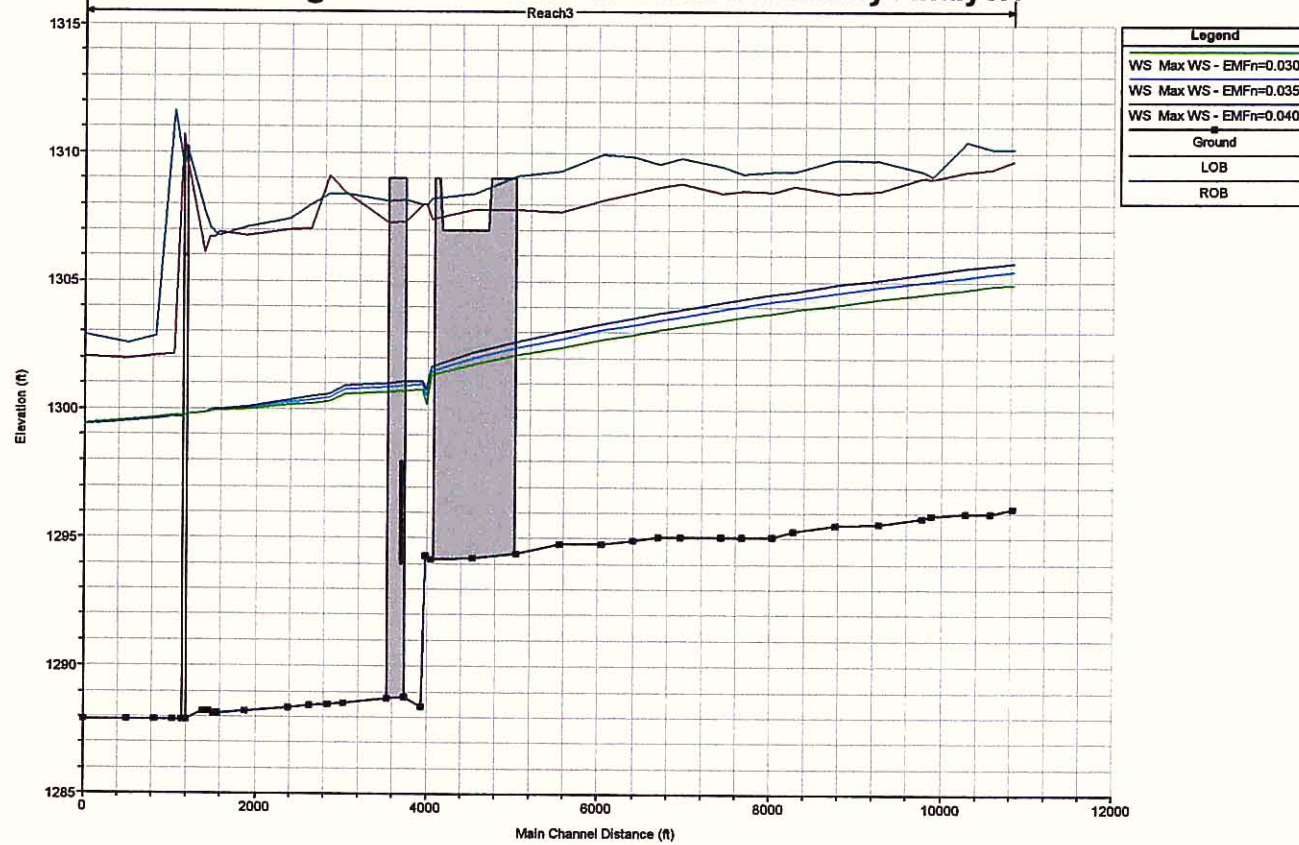
**Figure 5.3.2.3: EMF 'n' Value Sensitivity Analysis**

between profiles and the velocity varies by less than 0.5 fps along the entire reach. The slight increase in the EMF water profile slightly increases the tailwater on the basin's flap-gate outlet. However, the impact is insignificant, increasing the basin stage by 0.1 ft and the basin volume by approximately 10 acre-ft. Ultimately, an n-value of 0.040 was used for design in accordance to a previous study and at the direction of the FCDMC (Section 4.4.2.1).

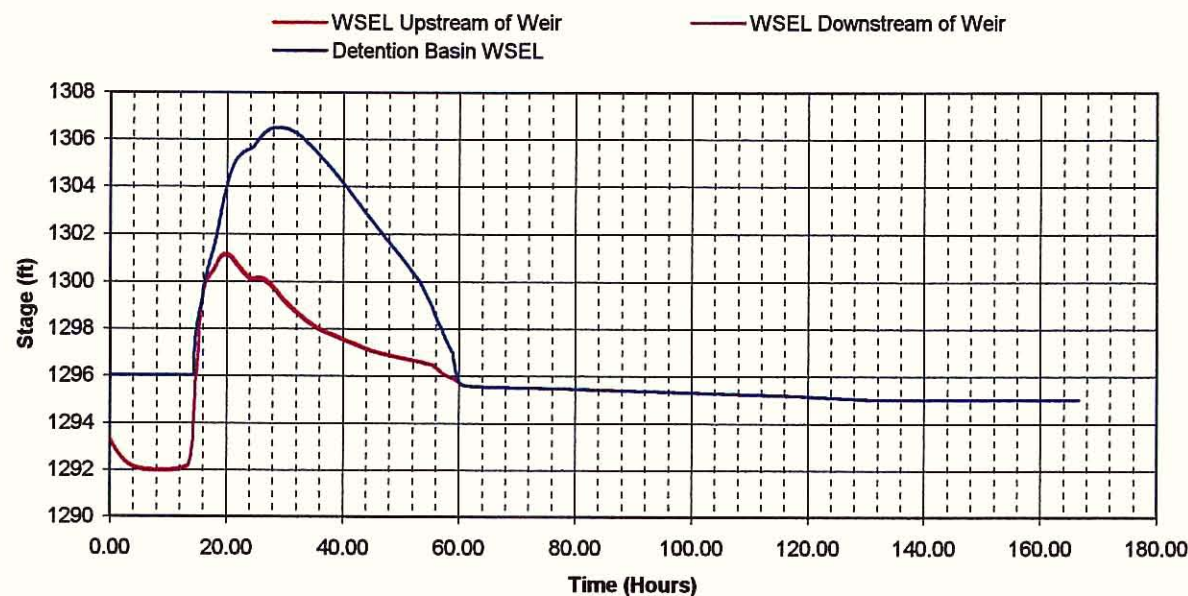
**Figure 5.3.7.1 - Stage Hydrographs at EMF/Chandler Heights Outlet**

Hydrographs from the Chandler Heights Basin analysis are depicted Figures 5.3.7.1 – 5.3.7.3. Figure 5.3.7.1 shows stage hydrographs for the Chandler Heights Basin and the EMF at the basin outlet. It shows the basin stage peaking at 1306.5 for a maximum storage volume of 1320 acre-ft and providing a minimum of 2 feet of freeboard around the basin. It also shows that within 36 hours, the basin drains to an elevation of 1296.3. The remaining 0.3

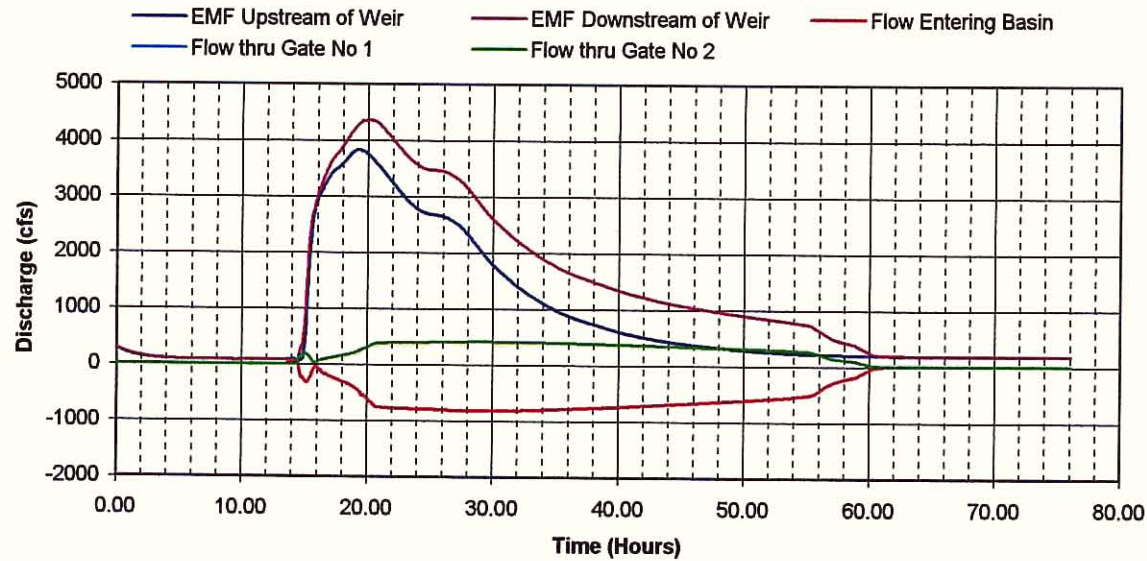
**Figure 5.3.7.2 - Flow Hydrographs at EMF/Chandler Heights Outlet**

feet of water should quickly dissipate through soil infiltration shortly, thereafter. Figure 5.3.7.2 shows the impact of the operation of the basin outlet on flow in the EMF channel. The peak flow in the EMF increases from approximately 3830 to 4370 cfs due to flow draining from the basin through the flap gates.

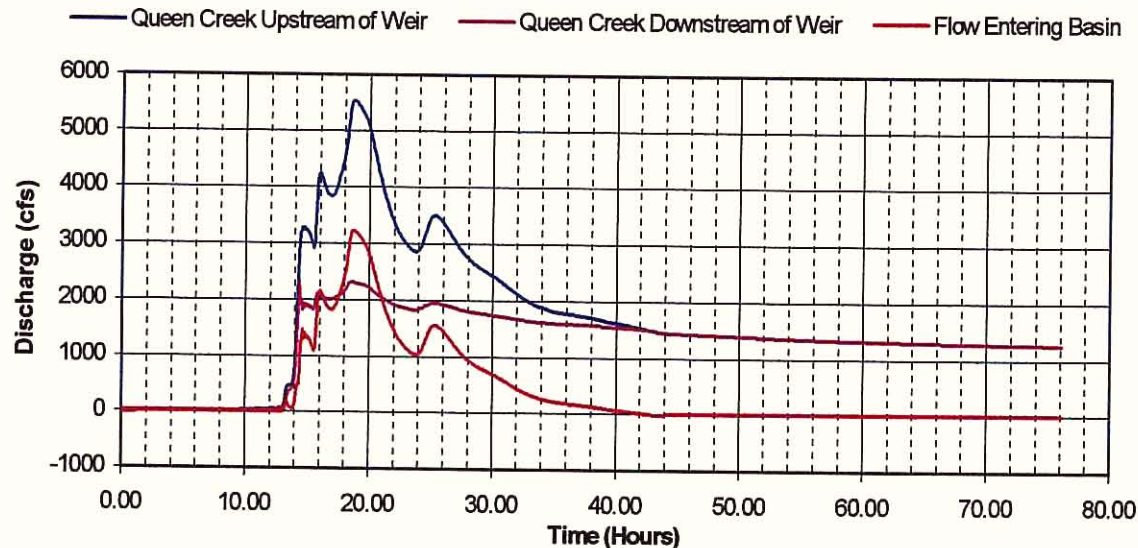
**Figure 5.3.7.3 - Flow Hydrographs at Weir on Queen Creek**

Figure 5.3.7.3 shows the operation of the lateral weir as it reduces the peak flow from 5540 to ~2340 cfs in Queen Creek by diverting it into the Chandler Heights Detention Basin.
